# Manhole Inspection Summary

Manhole # S4100\_031MH

Insp Date: **2/21/07 12:36 PM**

**Location** Address: **1200 DARLEY AVE**

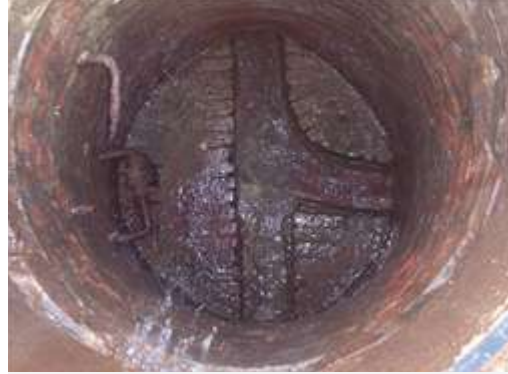
Top View

☐ Parged ☒ **Debris** (not Condition related)

Count: **3** Missing: **2** ☒ **Corroded**

☒ **Evidence Of Surcharge** Depth: **3** (ft.) ☐ Active Surcharge Present

Corroded and missing steps. Evidence of surcharge - Bench debris. Missing steps.

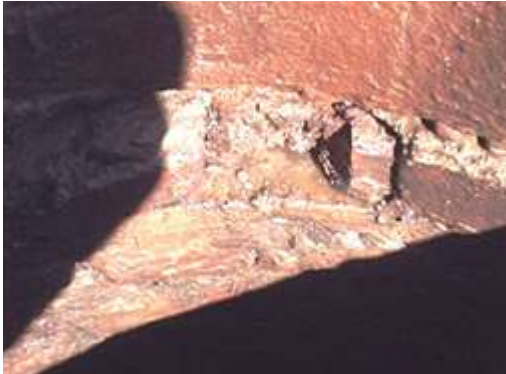
Defect

☒ **Leaks**

Condition: ☐ Sound ☐ Cracked ☐ Root Intrusion ☐ Loose Brick ☒ **Deteriorated**

Infiltration: ☐ None ☒ **Joint** ☐ Cracks ☐ Mortar ☐ Roots ☒ **Wall**

Frame leaks. Adjustment deterioration and infiltration. Loose brick.

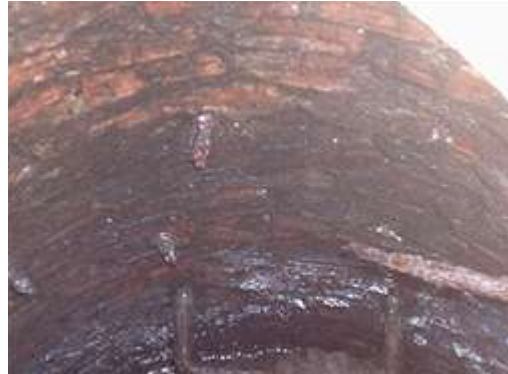
Defect

Infiltration: ☐ None ☐ Joint ☐ Cracks ☐ Mortar ☐ Roots ☒ **Wall**

Infiltration: ☐ None ☐ Joint ☐ Cracks ☒ **Mortar** ☐ Roots ☒ **Wall**

Corbel and Barrel infiltration.

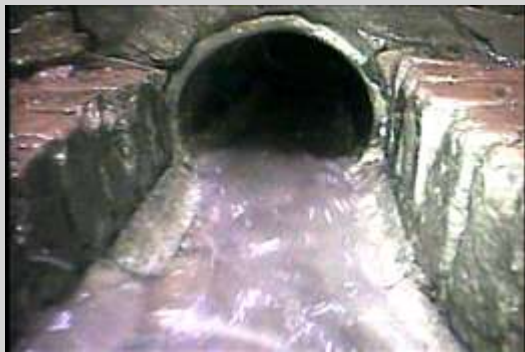
### 8 in. Circular Gravity Sewer Pipe Out @ 12 O'Clock

Condition: ☐ Sound ☐ Cracked ☐ Root Intrusion ☒ **Deteriorated** ☐ Leaks ☐ Debris

Channel and Bench deterioration.

Deposits: ☐ None ☐ **Mud** ☐ Sludge ☐ **Debris** ☒ **Grease**

Infiltration: **Evidence** Pipe Seal Cond: **Unknown**

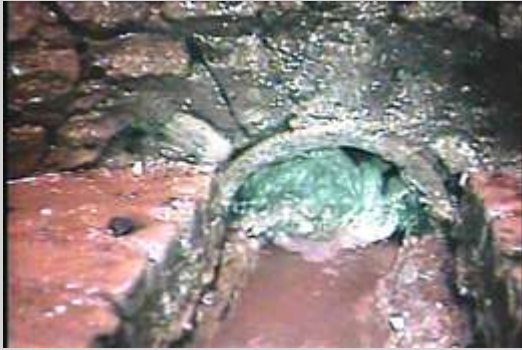
Pipe In @ 6 O'Clock

Barrel deterioration and infiltration.

Deposits: ☐ None ☒ **Mud** ☐ Sludge ☒ **Debris** ☒ **Grease**

Deposits Extent: **Heavy**

Pipe Seal Cond: **Broken**
